Lessons Learned: Radiation Protection for Emergency Response and Remediation / Decontamination Work Involved in TEPCO Fukushima Daiichi NPP Accident

Abstract. The paper described problems that occurred during emergency work at TEPCO Fukushima Daiichi NPP in 2011 and extracted lessons learned from the experiences for radiation protection and provided guidance regarding preparedness for a similar accident. The paper also provided information as a reference to persons responsible for legislation regarding radiation protection in an existing exposure situation.

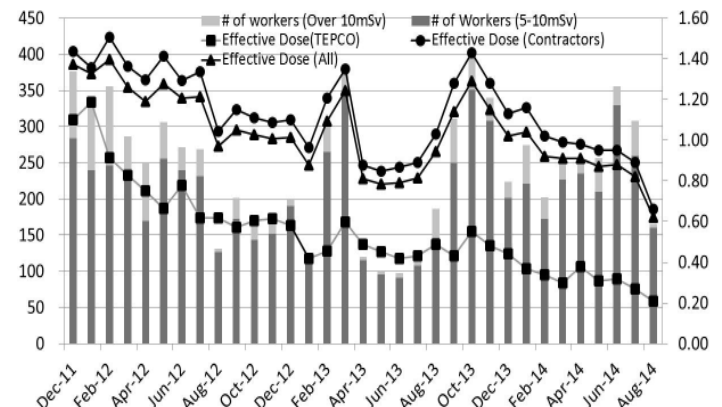
Figure 2. Trend of Radiation Exposure of Workers at Fukushima Daiichi NPP (December 2011-August 2014)

During the emergency period from March to November 2011, the maximum monthly dose and average monthly dose were 21.51 mSv and 4.69 mSv, respectively. The average number of monthly workers who were exposed to more than 5 mSv was 1,236 (Figure 1). From December 2011 to August 2014, the maximum and average monthly dose decreased to 1.40 mSv and 1.04 mSv. The average number of monthly workers who were exposed to more than 5 mSv were 245 (Figure 2). [3]
